Change the Cell Driver Package on Mesa Pro

Errors in the current Windows 11 cell driver package can cause the cell modem to disappear on the Mesa Pro. Sierra Wireless is resolving the issues with the cell driver, but a temporary solution is to change the cell driver package to the Generic Windows 10 driver and then load the carrier-specific firmware. To change the cell driver package, follow these instructions.

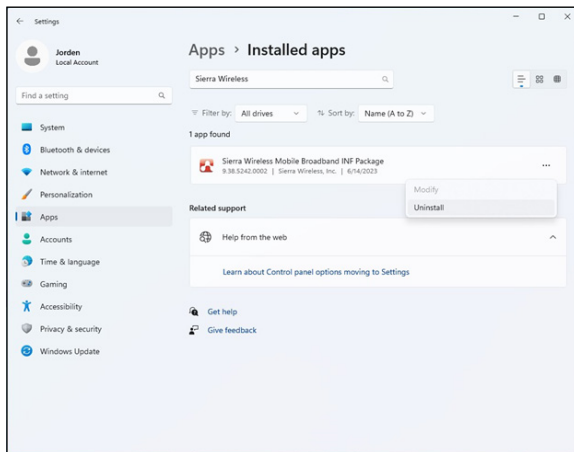
1. On the Mesa Pro, select **Settings > Apps > Installed Apps**.

2. Locate Sierra Wireless Mobile Broadband INF package, and tap the three dots.
3. Tap Uninstall.

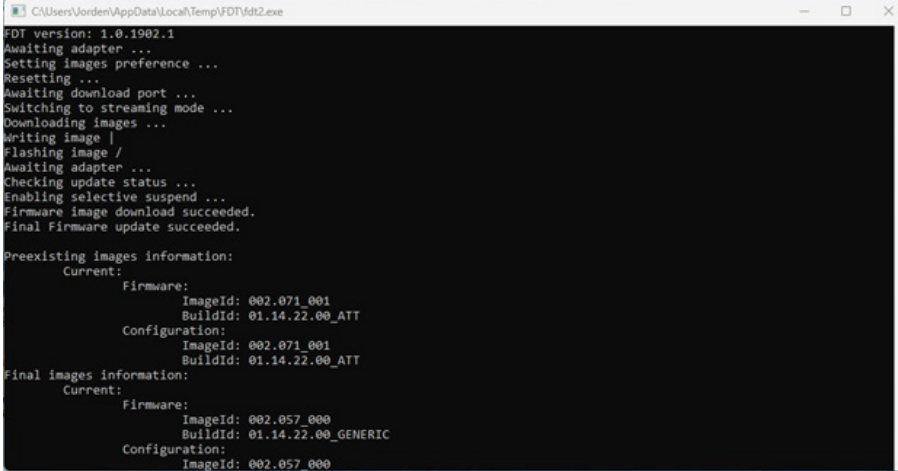
The carrier firmware utility firmware loads, as shown below.

```
C:\Users\Jordan\AppData\Local\Temp\FDI\fdt2.exe
FDI version: 1.0.1902.1
Awaiting adapter ...
Setting images preference ...
Resetting ...
Awaiting download port ...
Switching to streaming mode ...
Downloading images ...
Writing image |
Flashing image /
Awaiting adapter ...
Checking update status ...
Enabling selective suspend ...
Firmware image download succeeded.
Final Firmware update succeeded.

Preexisting images information:
Current:
  Firmware:
    ImageId: 002.071_001
    BuildId: 01.14.22.00_ATT
  Configuration:
    ImageId: 002.071_001
    BuildId: 01.14.22.00_ATT
Final images information:
Current:
  Firmware:
    ImageId: 002.057_000
    BuildId: 01.14.22.00_GENERIC
  Configuration:
    ImageId: 002.057_000
```
